DEVELOPMENT OF SPATTERED TECHNIQUES
FOR THRUST CHAMBERS
NAS 3-17792

Monthly Technical Progress Narrative
Number 3

Period of Performance: October 1 to October 31, 1973

Pratt & Whitney Aircraft
FLORIDA RESEARCH AND DEVELOPMENT CENTER
BOX 2691, WEST PALM BEACH, FLORIDA 33402

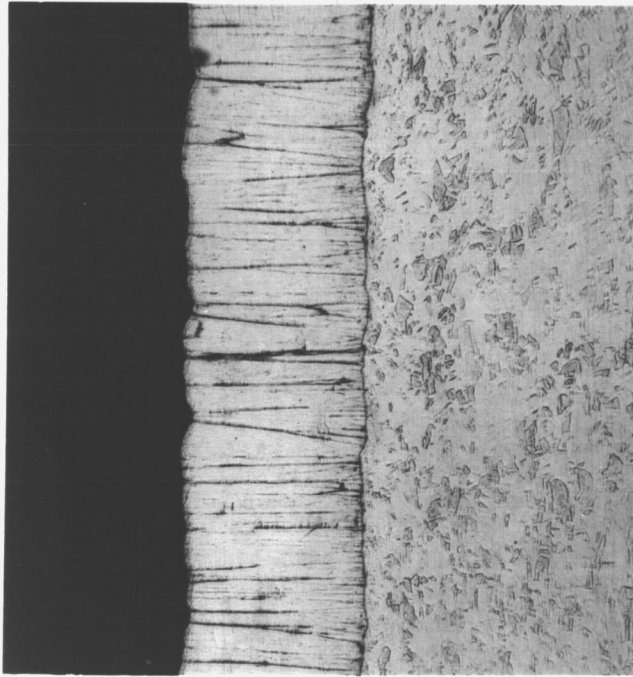
Run I-11

observed, see Figure 4, was probably a result of the higher sputtering rate and substrate temperature. Whether the higher temperature or the increased bias accounted for the decrease in cone formation is not clear. Furthermore, the stability of the discharge probably contributed to the lack of large cones. Note the similarity between this structure and the outer layer of Run I-7 (Figures 1 and 4).

FIGURE 5: MICROSTRUCTURE OF OFHC COPPER CLOSEOUT LAYER OVER CERROTRU^R FILLED OFHC RIBBED WALL CYLINDER (#3118-4). ETCHANT: 5gFeCl₃, 10 ml HCl, 50 ml GLYCERIN, 30 ml WATER.

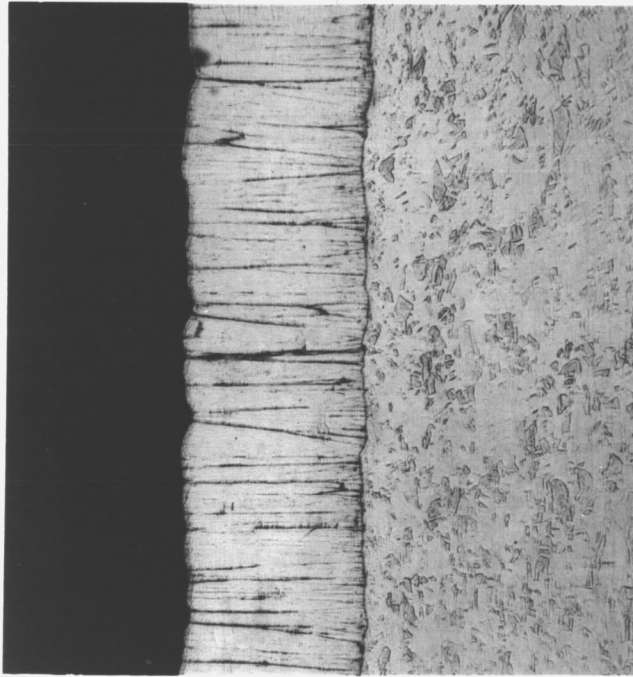
Run I-11

The structure of the coating shown in Figure 5 is similar to that for Run I-10 but contains more cones. The lower temperature depositions in general seem to contain more cones and as a result, higher temperature depositions are planned.

FIGURE 5: MICROSTRUCTURE OF OFHC COPPER CLOSEOUT LAYER OVER CERROTRUR^R FILLED OFHC RIBBED WALL CYLINDER (#3118-4). ETCHANT: 5gFeCl₃, 10 ml HCl, 50 ml GLYCERIN, 30 ml WATER.
